**AMBIENT MONITORING REPORT
STATE 30-16 PAD
KERR-MCGEE OIL & GAS ONSHORE LP**

Document Number: **085AA-011278-RT-130**
Reporting Period: **July 1 through July 31, 2022**
Report Date: **August 2, 2022**

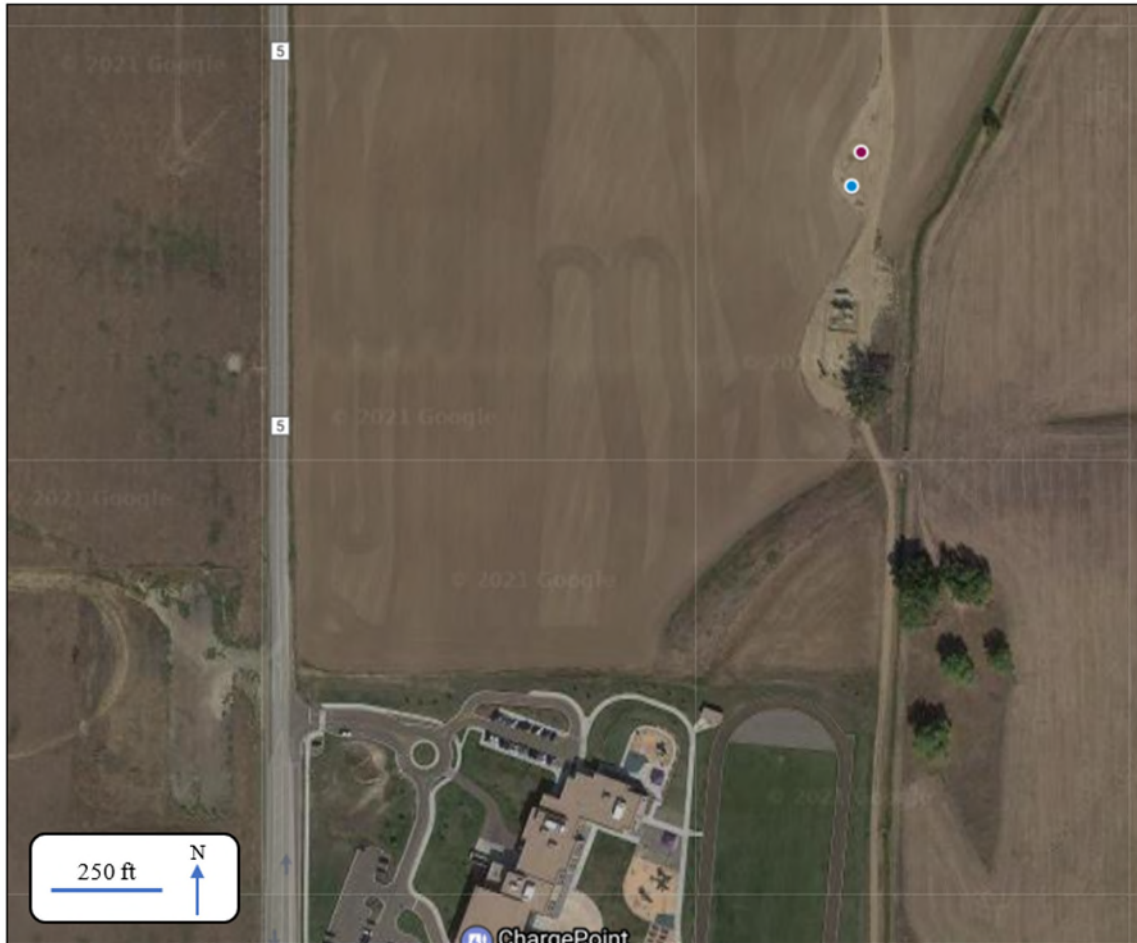
Sampling locations are labeled by ID on the map below.

Location Tag	Description

State Pad Monitoring Wells

PID Analyzer

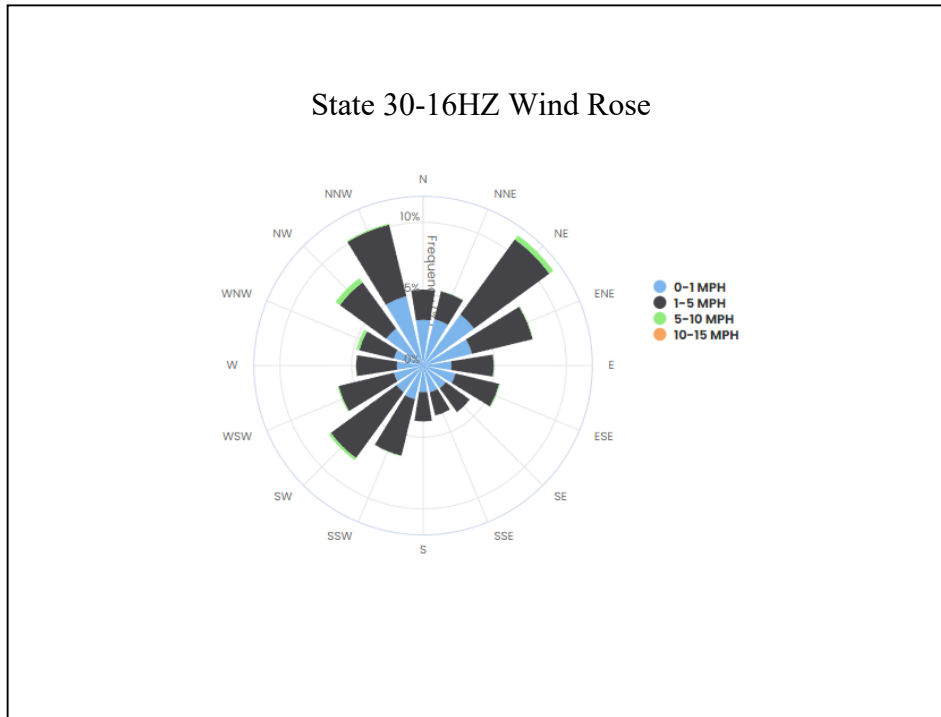
Figure 2 – State 30-16HZ Meteorological Data

The wind rose below is shown for State 30-16HZ facility and is plotted with 15-minute averages.

Meteorological data, collected on the PID analyzer onsite, for the reporting period can be found in the Figure 2.
